New Radiometer Tested for Measurements of Thin Clouds

Winter Weather Hampers Work at SGP

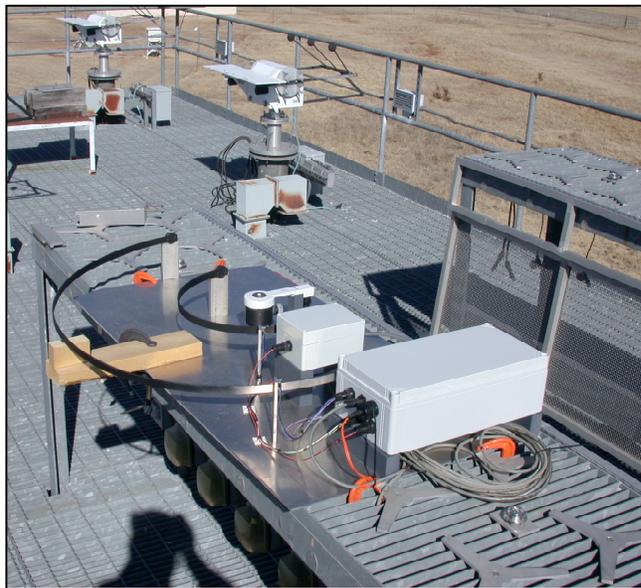
Figure 1. The TCRSR is shown here on the roof of the Radiometer Calibration Facility at the SGP site. Two "shadowbands" rotate around the radiometer's sensor, located just inside the smaller shadowband. They reflect light away from the sensor at multiple angles so that it simultaneously records signals of scattered light (ARM photo).

The TCRSR measures the angular distribution, or spread, of light from the sun scattered toward the instrument in six narrow spectral bands. The six bands, each approximately 10 nanometers (nm) wide, are centered at 415, 500, 610, 660, 870, and 940 nm. The prototype instrument was designed and tested in the summer and fall of 2007. After its promising initial performance, the TCRSR was deployed at the SGP site in early January 2008. Its observations there will be compared to data from other ARM instruments. If the results are favorable, the TCRSR may be considered for routine deployment at all ACRF sites.

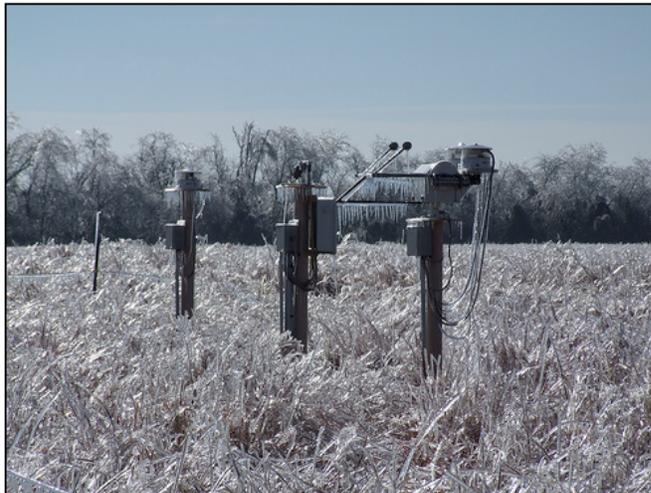
Figure 2. Two days after the mid December ice storm, the downwelling radiometers at Plevna, Kansas, were still encased in ice (James Martin photo).

One of the worst ice storms in recent history moved through Oklahoma and a large part of the Midwest on December 9-11, 2007. Data collection and delivery suffered when half of the SGP extended facilities lost power or communications. Immediately, all available SGP staff members were dispatched to visit the instrument stations and evaluate the damage.

The evaluation, occurring as power was restored by the local power company crews, took 7-10 days. Surprisingly, the instruments had suffered little damage, except for blown fuses and power-related computer issues. Through tireless effort, the SGP staff quickly restored normal operations and restarted the data flow.

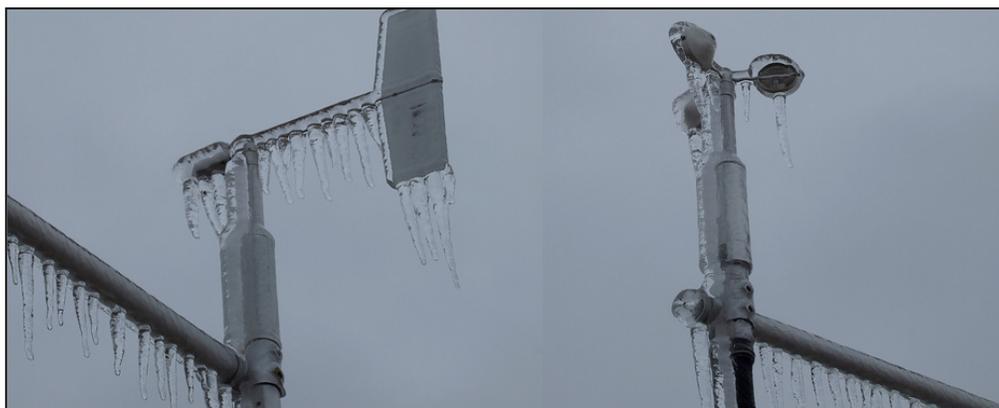
Figure 3. The wind speed and direction sensors of the energy balance Bowen ratio system at Hillsboro, Kansas, were frozen in place by the ice deposited in the mid December storm (James Martin photo).
